West Side Erosion Investigation – Bijou Lake

Bijou West Side Investigation
Figure 1

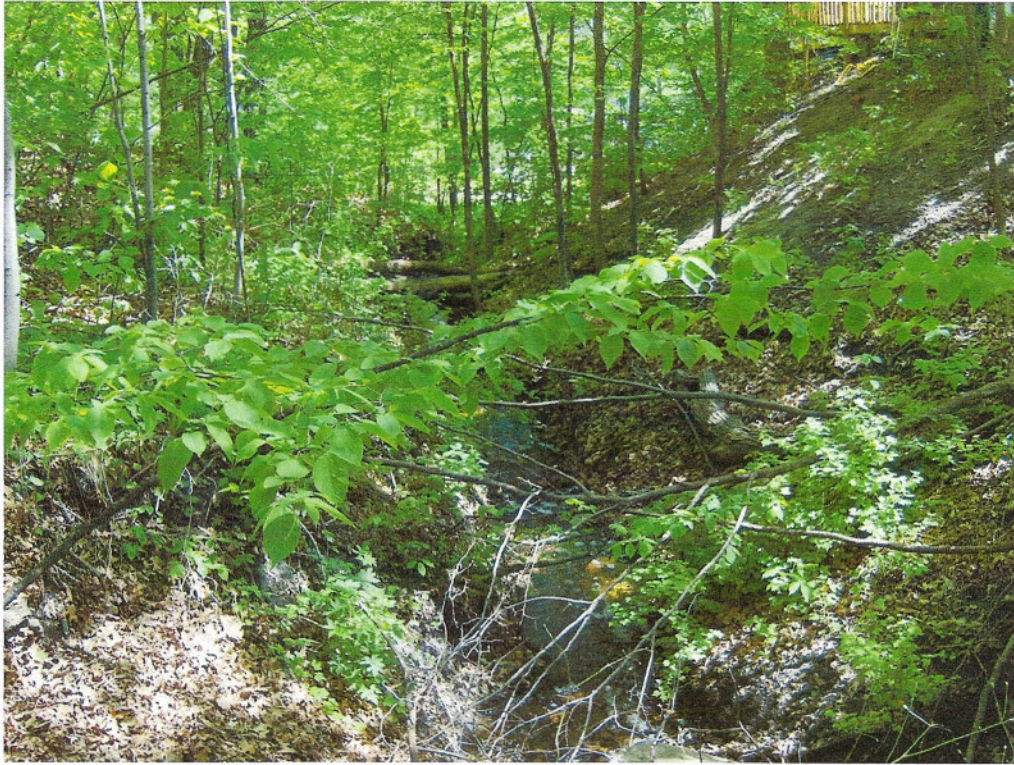
The runoff is causing erosion between the culvert through West Alpine Lane and the lake (see Photo #1). The area is very steep (approximately 1:1 slopes) and the culvert has been undercut and a section has separated (see Photo 2). The area is unstable and could cause problems with the adjacent lots and associated septic systems. When runoff reaches the lake just downstream of the culvert it is believed to be depositing sediment and nutrients both from the bank erosion near the culvert and the agricultural runoff further up in the watershed.

Photo #1 - Gully Looking East from West Alpine Lane

The second part of the project would be to address the erosion and bank stability problems between West Alpine Lane and the lakeshore. One approach to this area would be to replace the existing pipe with a much longer pipe that would extend beyond the area that is eroding, approximately 75% of the distance between the road and the lakeshore. The entire gully could be filled in to match the adjacent slopes down to the lakeshore. At

the downstream end of the new culvert, the area would be armored with riprap to prevent any erosion and reduce the runoff velocity prior to entering the lake.

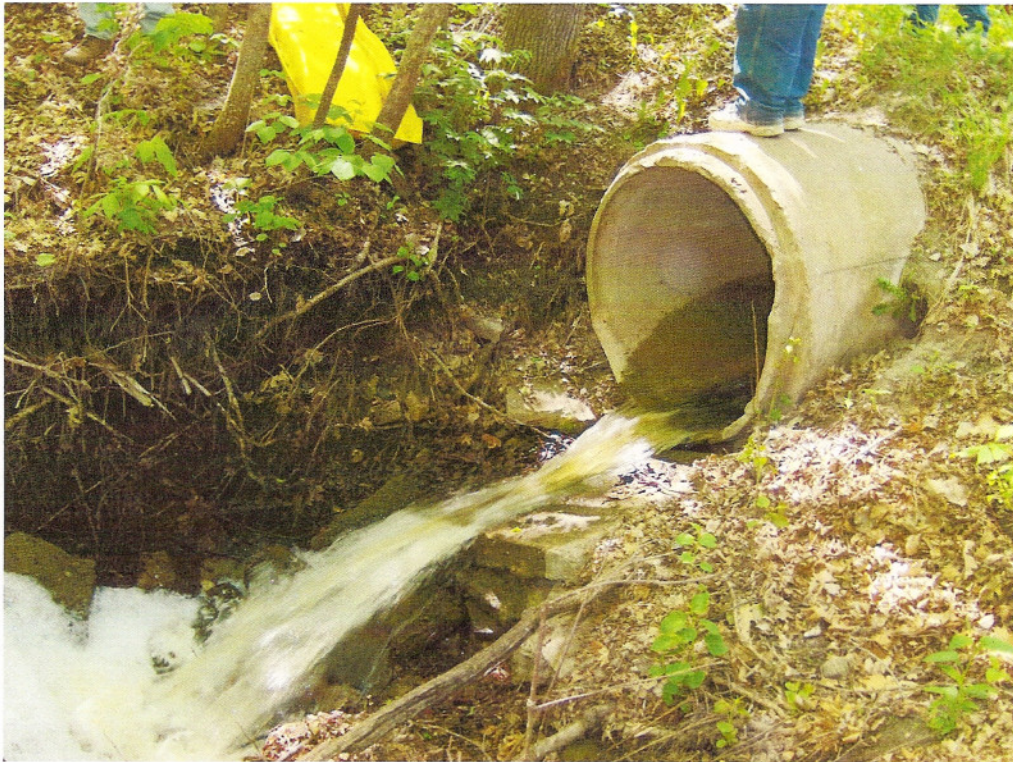
Photo #2 - Separated Culvert Just Downstream of West Alpine Lane

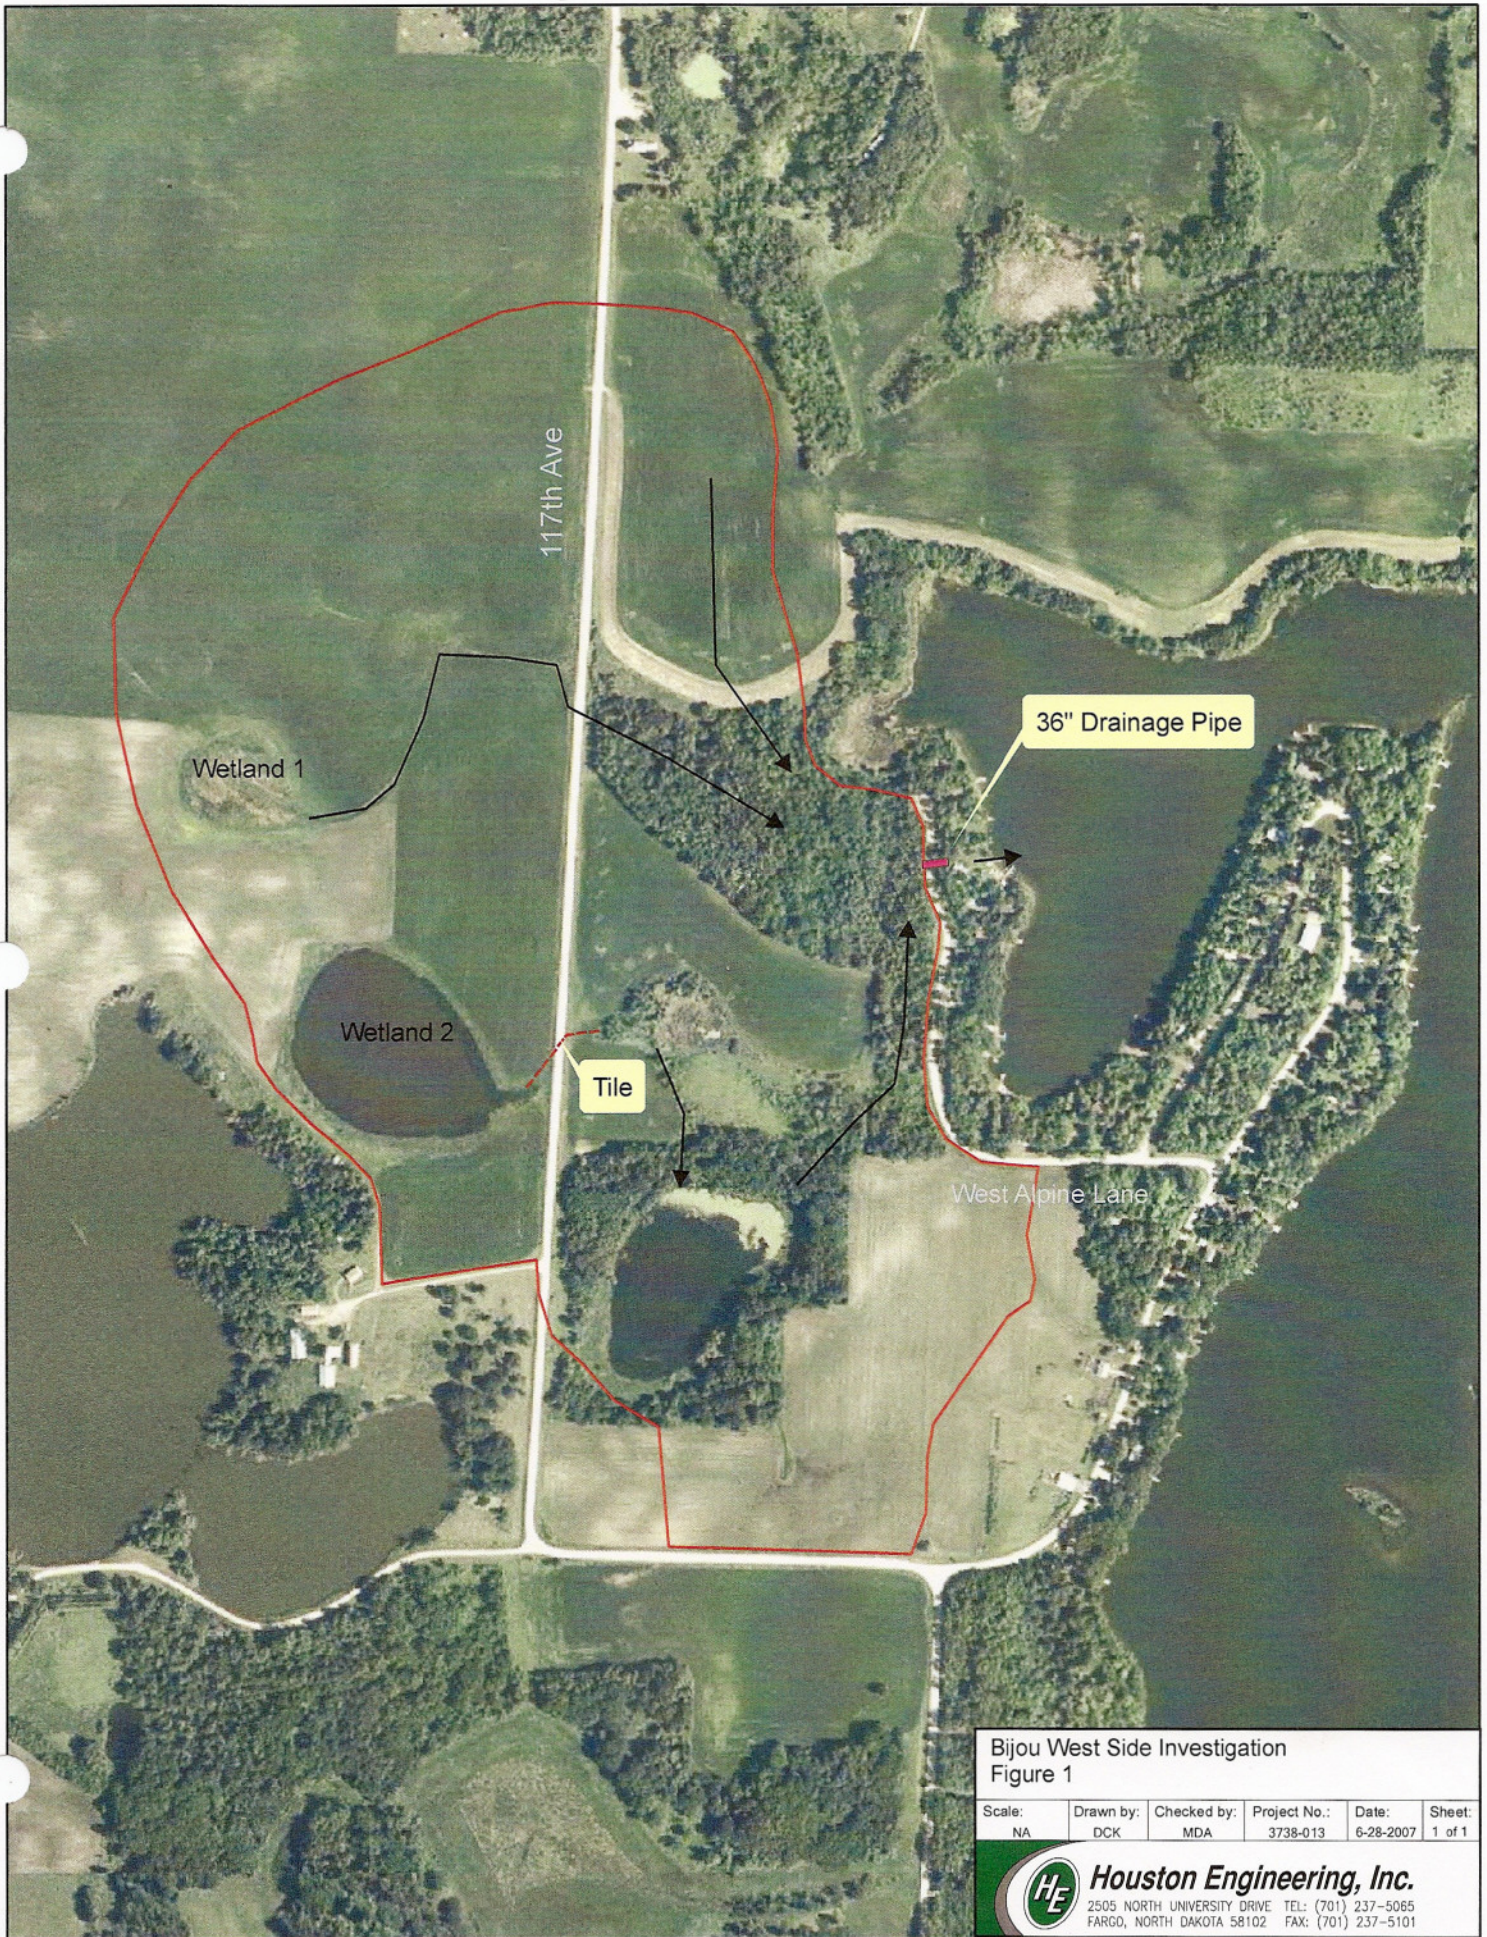
Runoff travels east from a watershed area of approximately 200 acres through a 36 inch culvert in West Alpine Lane to Bijou Lake. The contributing watershed and runoff patterns are shown on Figure 1. Approximately 50% of the contributing drainage area is in agricultural production. The remaining areas consist of hardwood forest, wetlands, roadways, and residential lots. Two large partially drained wetland areas are located west of 117th Ave and receive much of the agricultural runoff in the watershed. The north basin is partially drained by a surface ditch while the south basin is partially drained from a subsurface tile (see Figure 1).

The first part of the proposed solution is to address the agricultural runoff from areas west of 117th Ave. The large tiled wetland (Wetland #2) is likely trapping much of the sediment that is carried into it because of the subsurface inlet. This area could be improved by establishing vegetative buffers surrounding the wetland basin. This would further prevent sediment from entering the basin and further reduce the potential for sediment and nutrients from entering the lake.

The north wetland (Wetland #1) and the associated drainage area have the potential to be a significant source of sediment and nutrients. This partially drained wetland has a surface ditch that flows west under 117th Ave and then through a wooded area to the culvert under West Alpine Lane. The surrounding fields have steep slopes and are currently in row crop production. During significant rainfall events, agricultural runoff
